# Service Bulletin: Control Software Fault

This service bulletin addresses Conviron chambers originally equipped with CMP6060 controllers. Should one or more of your Conviron reach-in or walk-in chambers utilize a CMP6060 control system (pictured at right), this service bulletin will offer guidance accordingly.

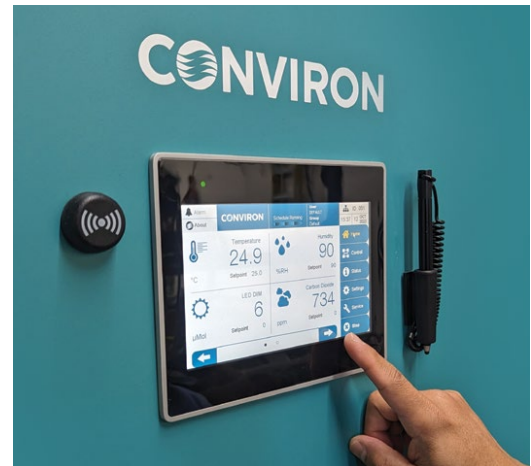
A small number of clients have reported controller malfunctions during operation changes to the controller touch screens, such as the screen not waking up from sleep mode or random stop-program issues. The error is attributable to a software fault in the touchscreen itself and/or the CMP controller. As a precaution, we are informing users so they can take appropriate steps.

Users, service personnel and/or facility managers that have experienced the fault should reach out to Conviron's service department as outlined below. If you are unsure whether your chambers are a) equipped with a CMP6060 controller or b) are supplied with software version 6.7 to 7.11.1, or touchscreen firmware version less than version 1.61C, please contact Conviron with your chamber's serial number and we will provide an assessment for you. If your equipment does have this software/firmware version, one of our technicians will provide you with the software/firmware update as well as instructions for uploading and rebooting. Our service department can be reached at:
